TDD# F5-8103-11

HOOVER B+B / WASHTENAW Co.
(SALINE DIE CASTING)

SECTION III - ON-SITE INSPECTION/SAMPLING

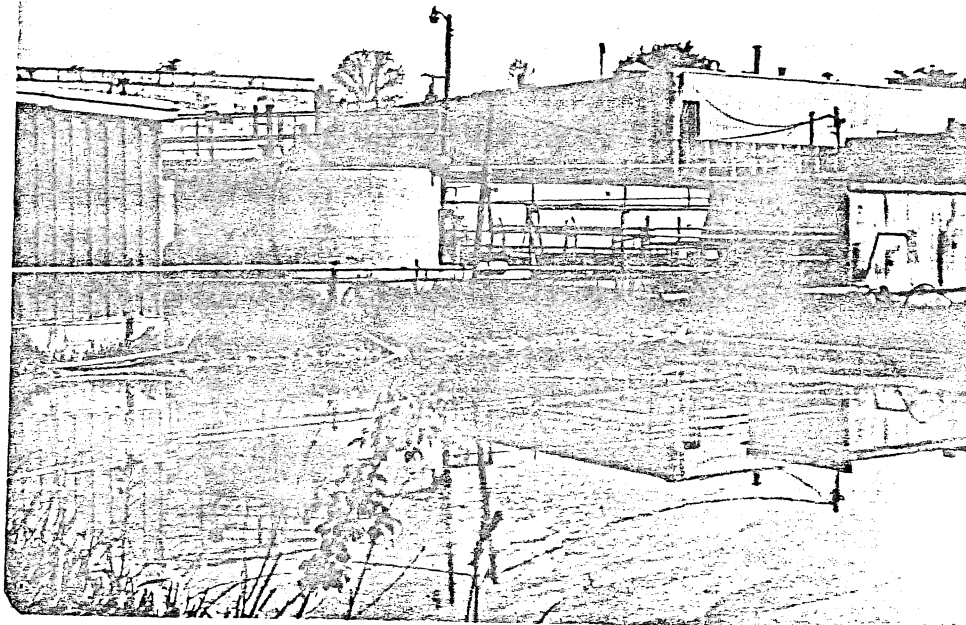
Comments: Photograph taken

toward the NORTHEAST, SHOWING

SETTLING POND #2

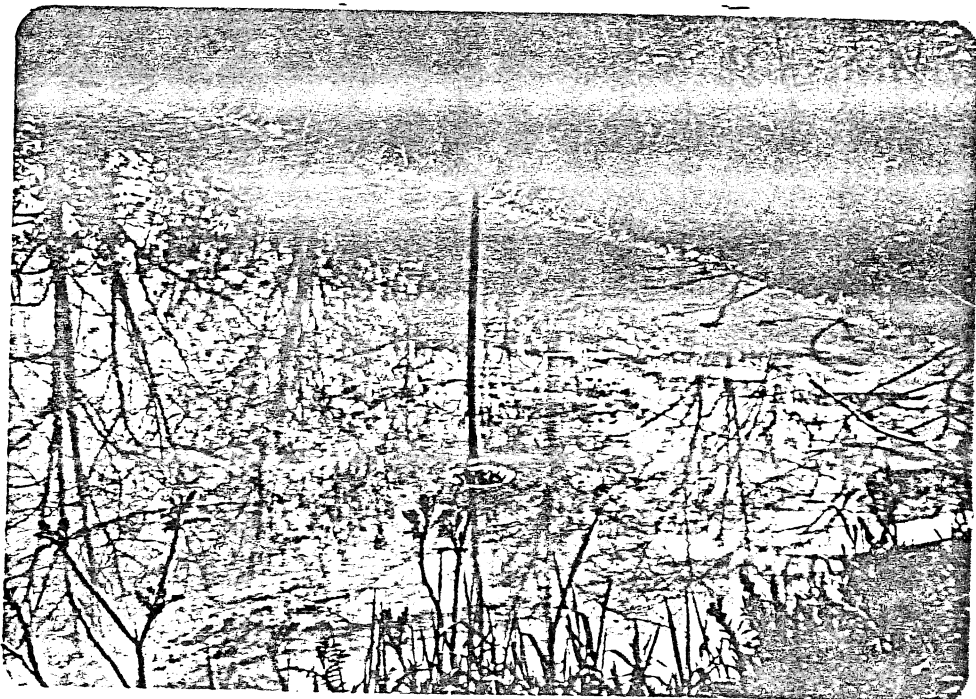
Comments: Photograph taken

toward the SOUTHEAST, SHOWING

DRAINAGE PIPE

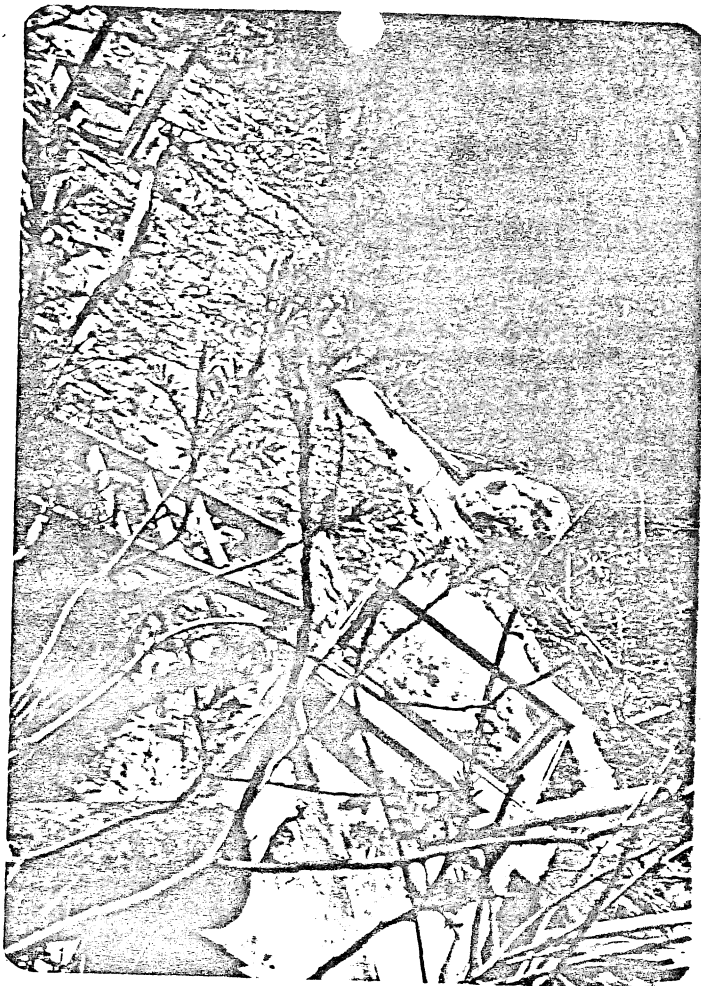
Comments: Photograph taken

toward the SOUTHWEST, SHOWING
THE SITE'S PERMITTED DISCHARGE
THAT DRAINS INTO THE SALINE RIVER

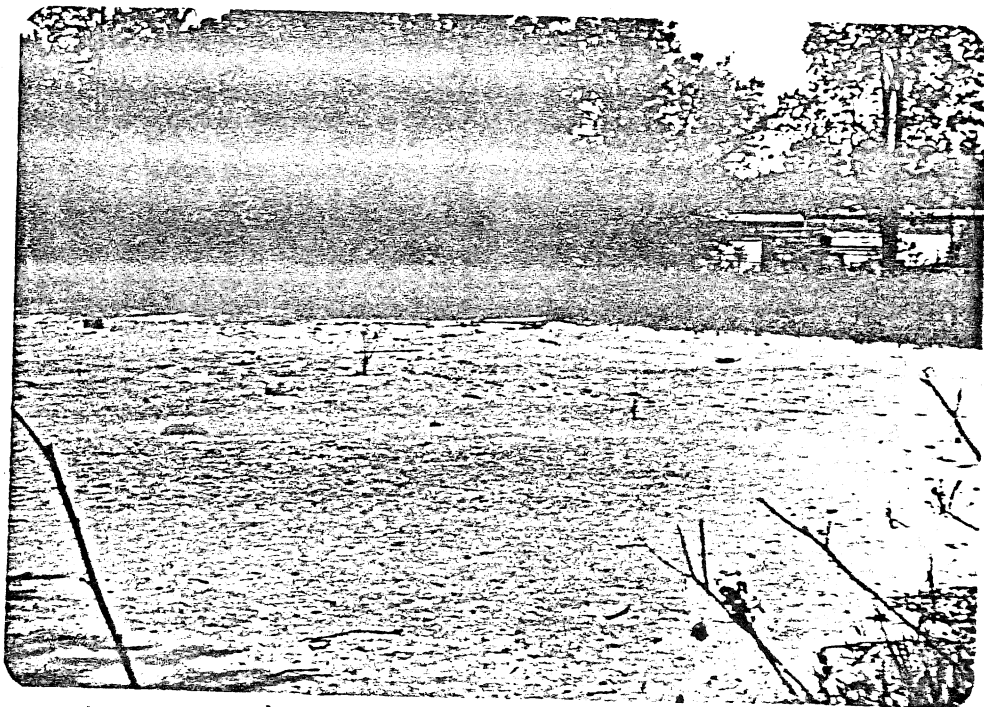
Comments: Photograph taken

toward the NORTH, SHOWING
UNUSED SLUDGE POND ACROSS
THE RIVER FROM THE SITE

Groundwater contamination is believed to be occurring from the plants unused sludge pond and also from the unlined settling ponds. Potential contamination to the upper aquifer and not just the lower aquifer as specified by the MDNR is also believed to be occurring, with the possibility for the contamination to by-pass the Saline River in part and move into a more regional flow. Therefore a semi-detailed hydrogeological evaluation should be made to fully define the geology and hydrogeology of the area.

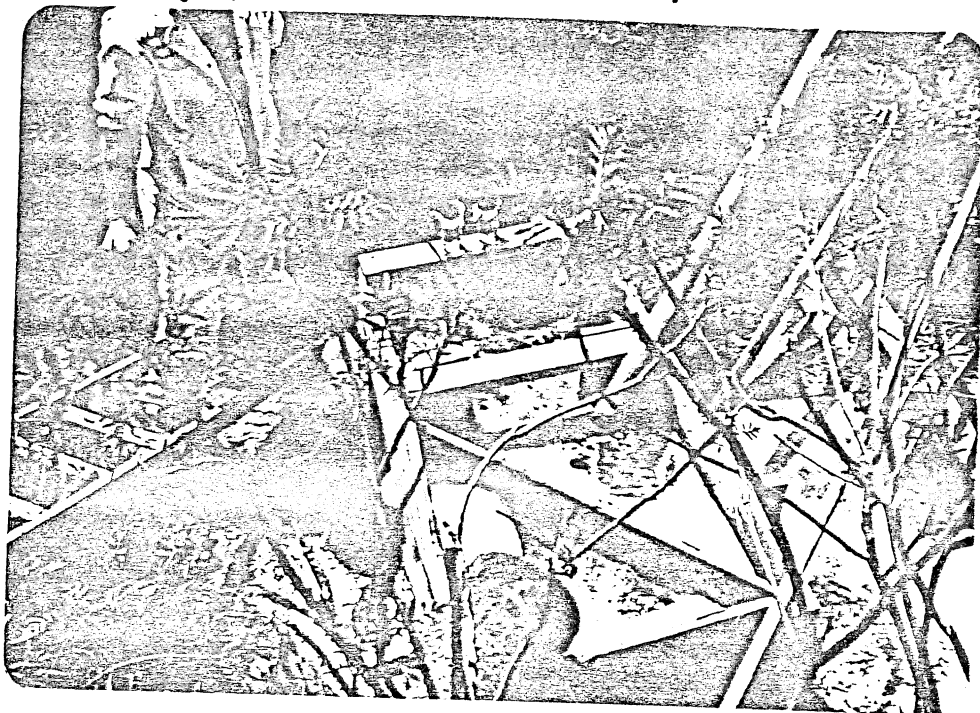
Comments: Photograph taken

toward the SOUTHWEST, TAKING A

SAMPLE OF THE DISCHARGE

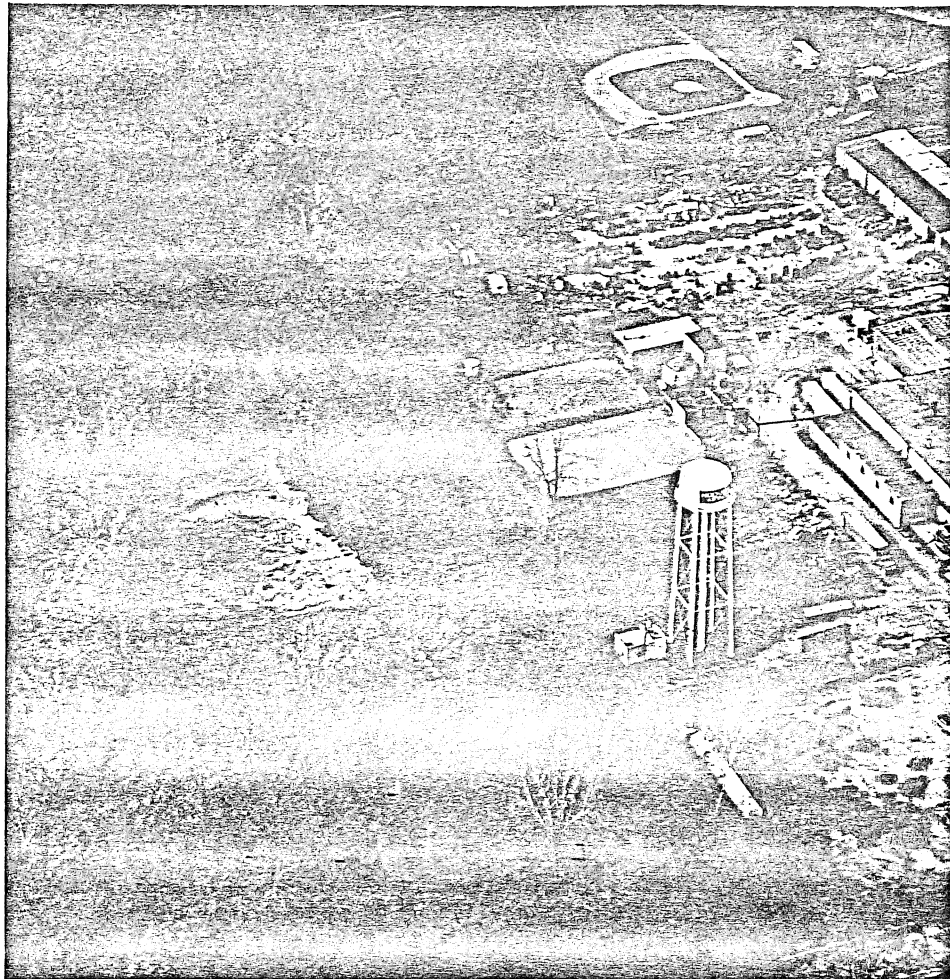
THIS AERIAL WAS TAKEN OF THE PLANT BY THE COMPANY DURING 1981 AND GIVEN TO THE INSPECTION TEAM. THIS PHOTO SHOWS BOTH SETTLING PONDS AND THE SLUDGE POND ACROSS THE RIVER
